Damage Assessment of Pine Wood Facades in the First Years of Service for Sustainable Maintenance

Keywords: wood facades; *Pinus sylvestris*; aging evaluation; inspection; damage classification; maintenance plans

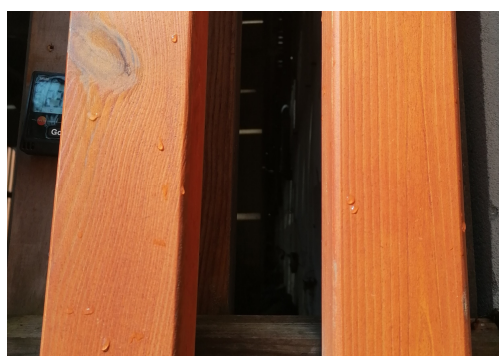
The different areas of the building's facades' wood elements, previously defined (Figure 1), were classified according to the proposed AB scale, based on an inspection made in July 2022. In the zones in service since 2019 or later, no signs of degradation were found, and the classification assigned corresponded to grade A0B0. The image in Figure 6 shows one of these zones, where it is possible to see some drops of water on the surface after watering the wood, thus evidencing its water-repellent capacity.

Figure 6. Wood elements in grade A0B0 (photograph in zone NE-φ-2017/17).
